SITE INSPECTION

**SBA SHIPYARD INC.
9040 Castex Landing Road
Jennings, Jefferson Davis Parish, Louisiana**

CERCLIS Number: LAD008434185

August 6, 2014

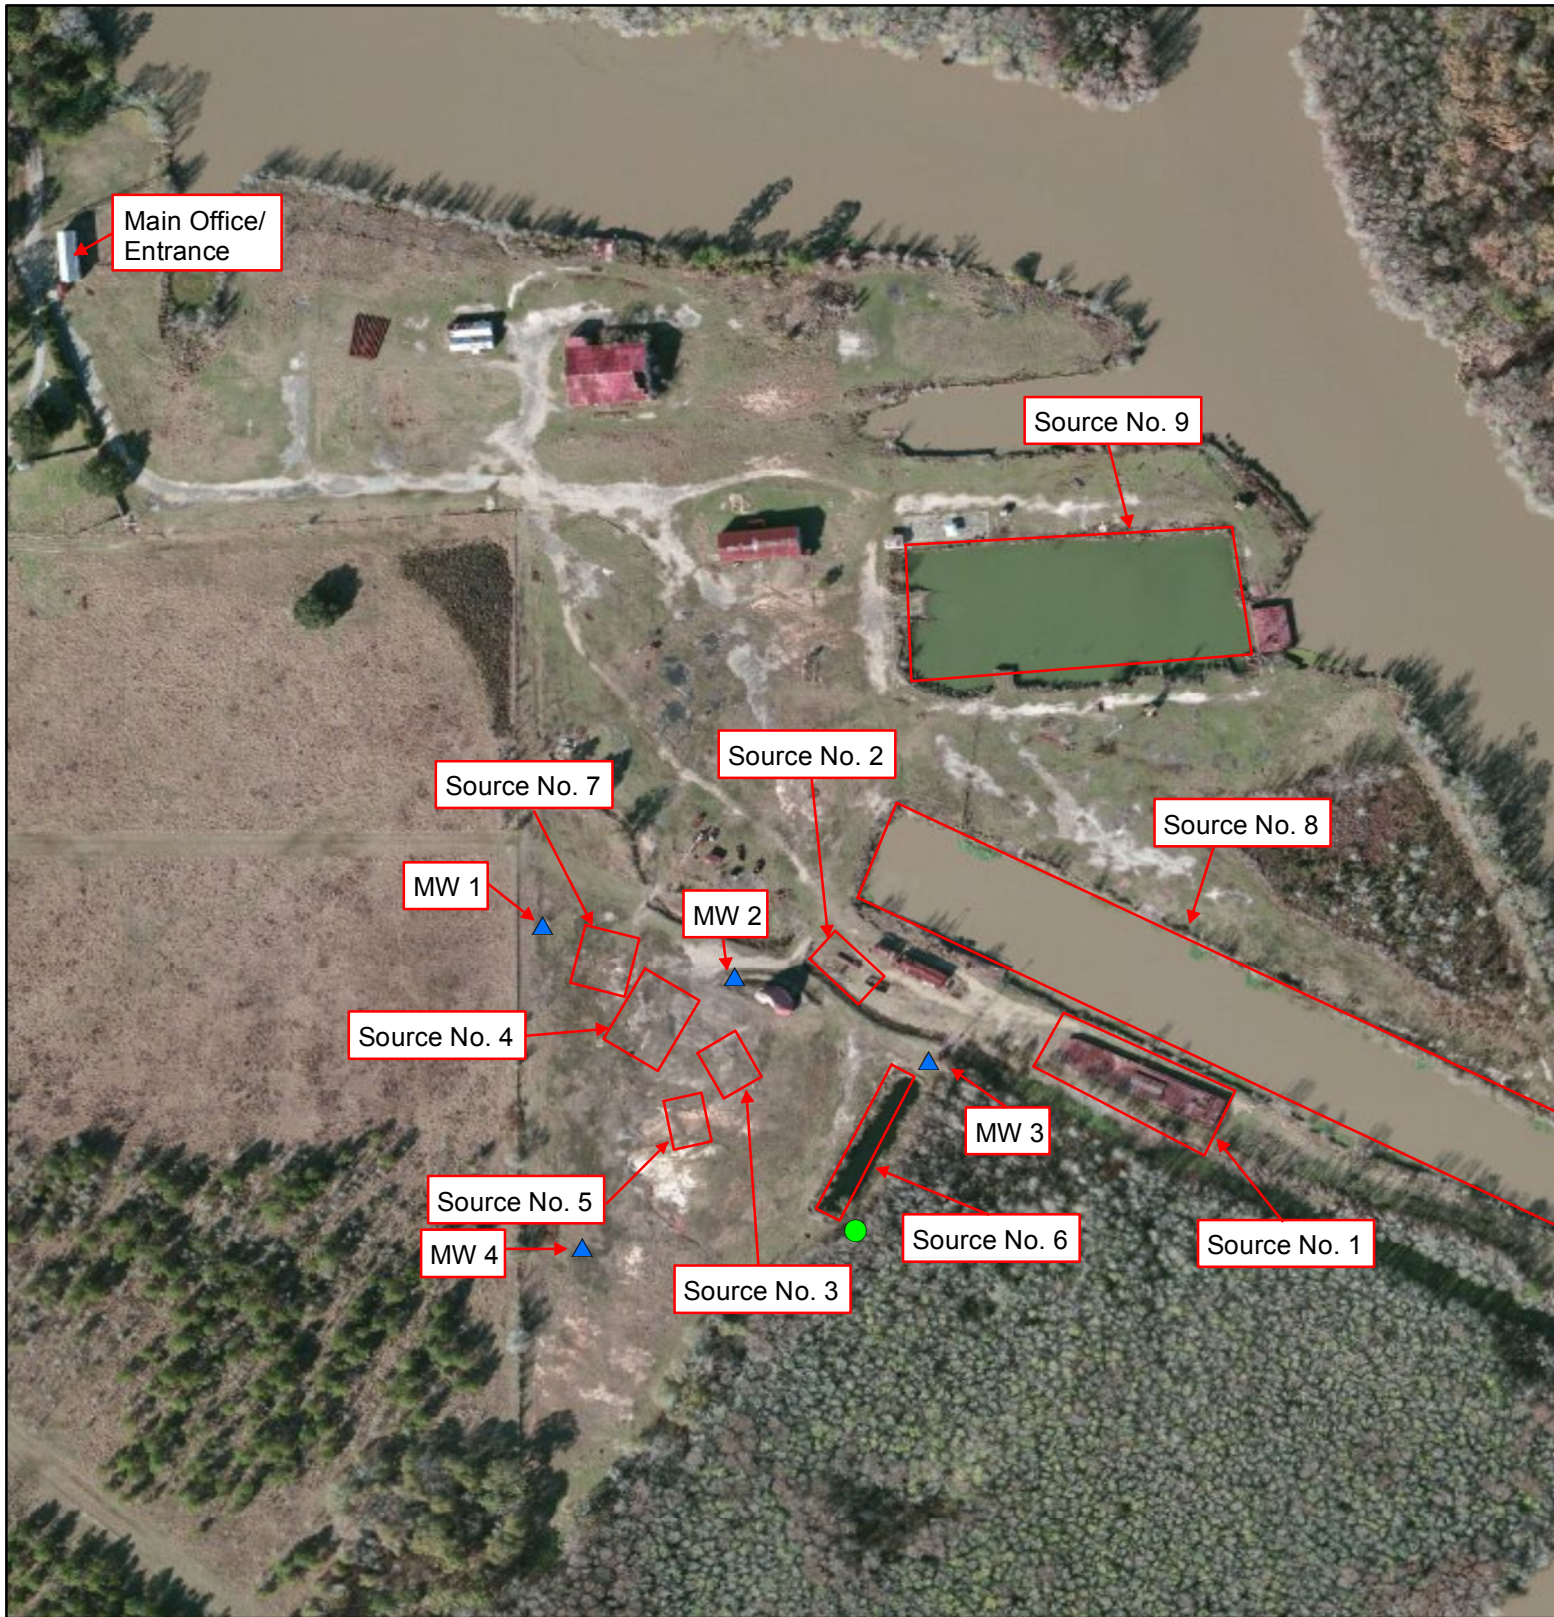
- Monitor Well (Unknown)
- ▲ Monitor Well
- Sources

Figure 4 provides the approximate layout of the sources located at SBA Shipyard. Sources at SBA Shipyard include the following:

- Source No. 1 - partially buried barge. The barge is approximately 250 feet (ft.) by 50 ft. The steel barge is located on the southeast portion of the property, north of a designated wetland area. Waste oil and fluids from the barge are being released into the aforementioned wetlands (Ref. 7, p. 56-57). An anonymous caller notified the National Response Center (NRC) in October 2012 that the barge was being scrapped and oil was being discharged to the surrounding soils. The material was also allowed to burn (Ref. 8, p. 2). LDEQ conducted an investigation and reported evidence of the scrapping efforts and that the burning of oil was extinguished (Ref. 9, p. 2).

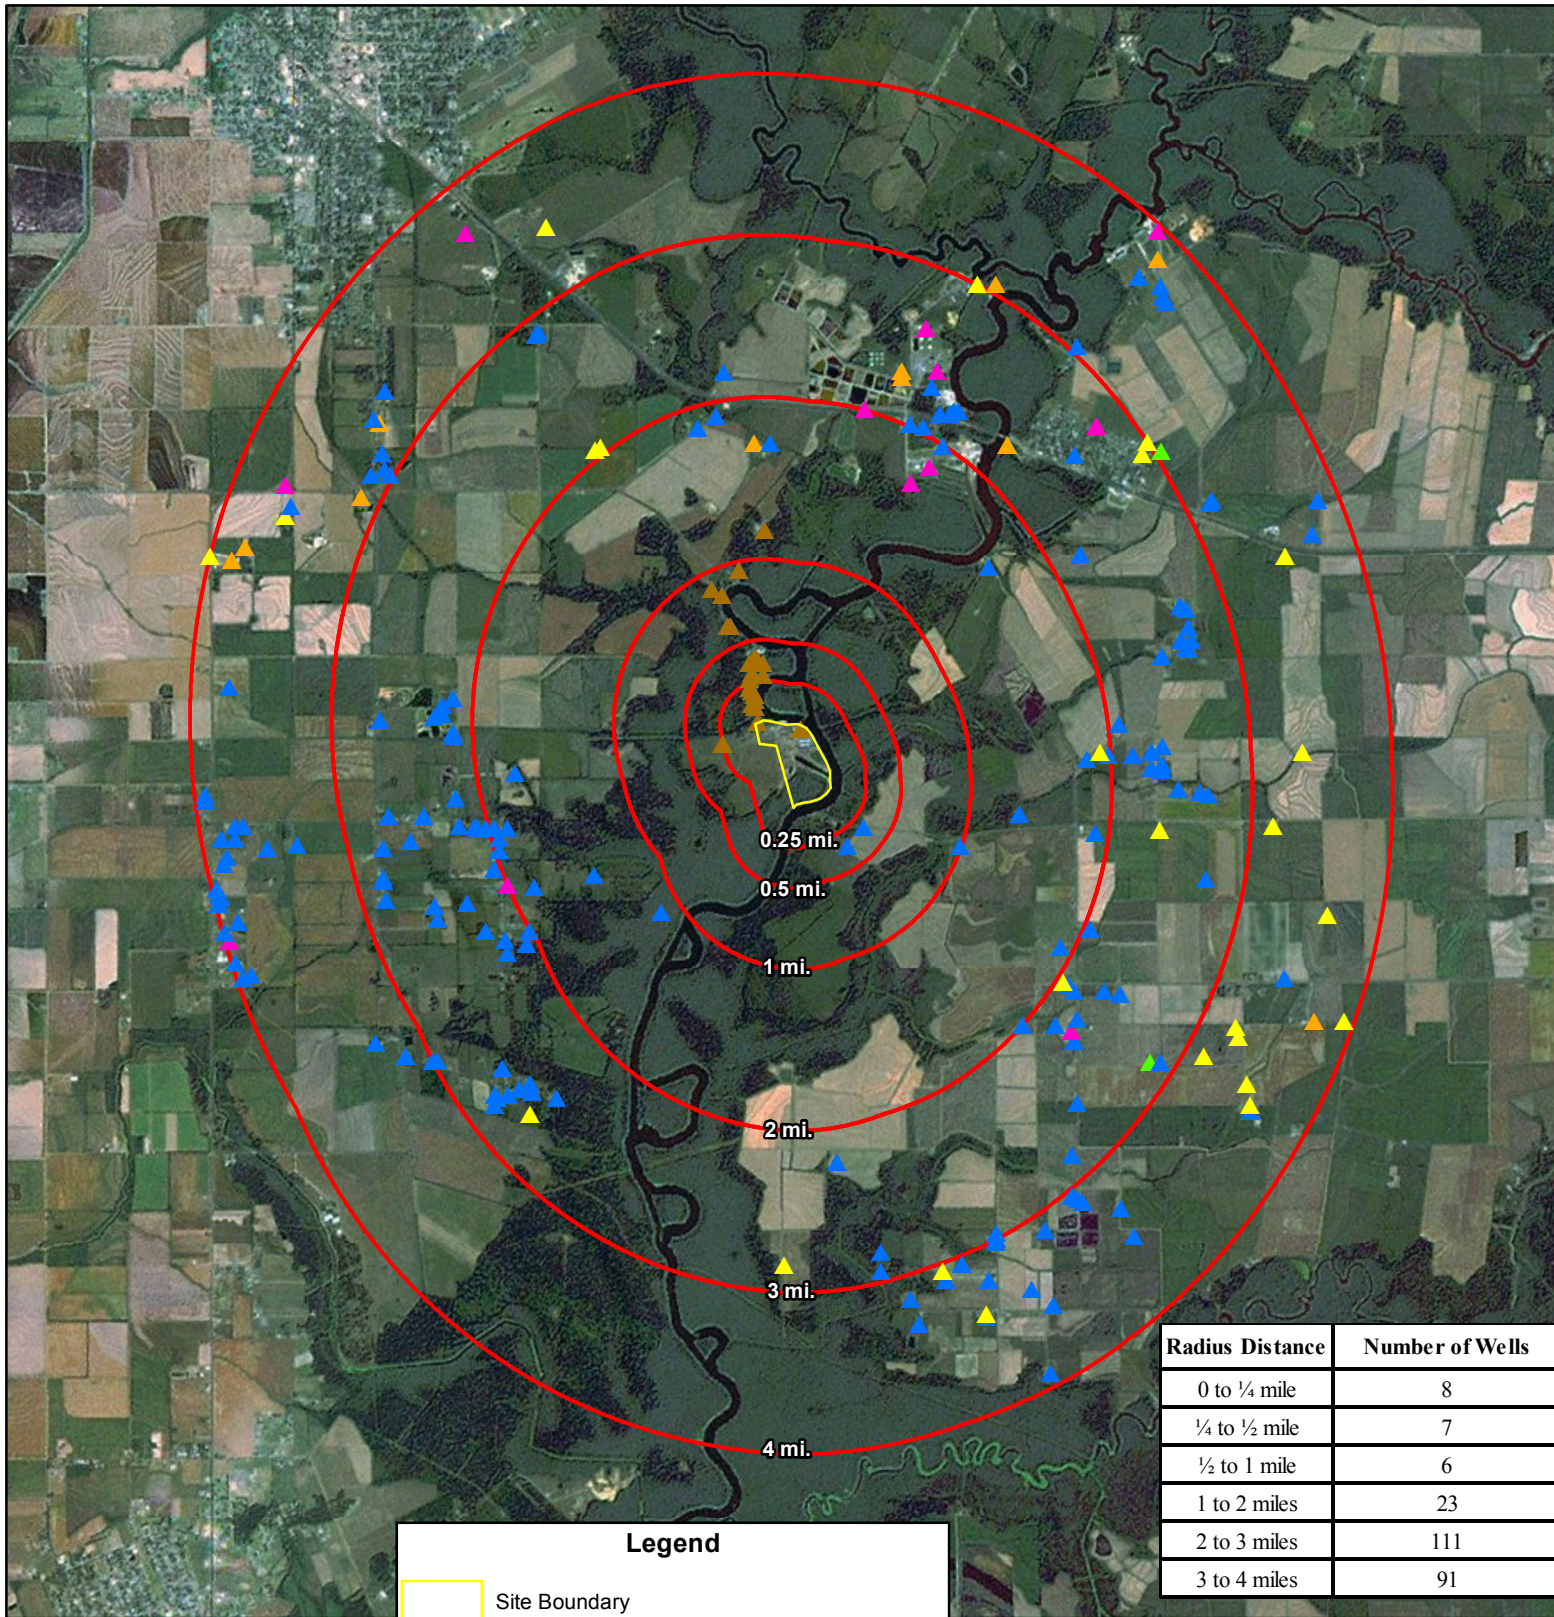
Figure 6. 4-Mile Groundwater Migration Receptors for SBA Shipyard
9040 Castex Landing Road, Highway 3166,
Jefferson Davis Parish, Jennings, LA 70546

Radius Distance	Number of Wells
0 to ¼ mile	8
¼ to ½ mile	7
½ to 1 mile	6
1 to 2 miles	23
2 to 3 miles	111
3 to 4 miles	91
